Manhole Inspection Summary

Manhole # S45I__012MH

Insp Date: **4/24/08 8:47 AM**

Location Address: **424 portugal st** Cross Street: **s wasington st**

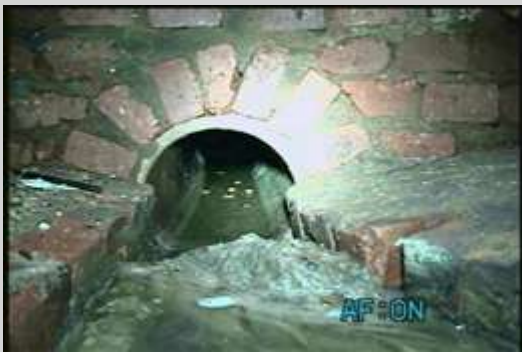
12 O'Clock Outflow

8 in. Circular Gravity Sewer
Pipe Out @ 12 O'Clock

Pipe Material: **Clay** ☐ Pipe Lined

Deposits: ☒ None ☐ Mud ☐ Sludge ☐ Debris ☐ Grease

Infiltration: **None** Pipe Seal Cond: **Unknown**

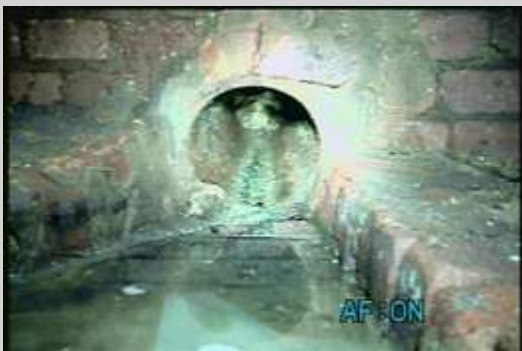
3 O'Clock Inflow

8 in. Circular Gravity Sewer
Pipe In @ 3 O'Clock

Pipe Material: **Clay** ☐ Pipe Lined

Infiltration: **None** Pipe Seal Cond: **Unknown**
